White Paper

Better Corrosion Protection for Dry and Pre-Action Fire Sprinkler Systems - Vapor Corrosion Inhibitors Outperform 98 % Nitrogen in Mil Loss Testing

December, 2024

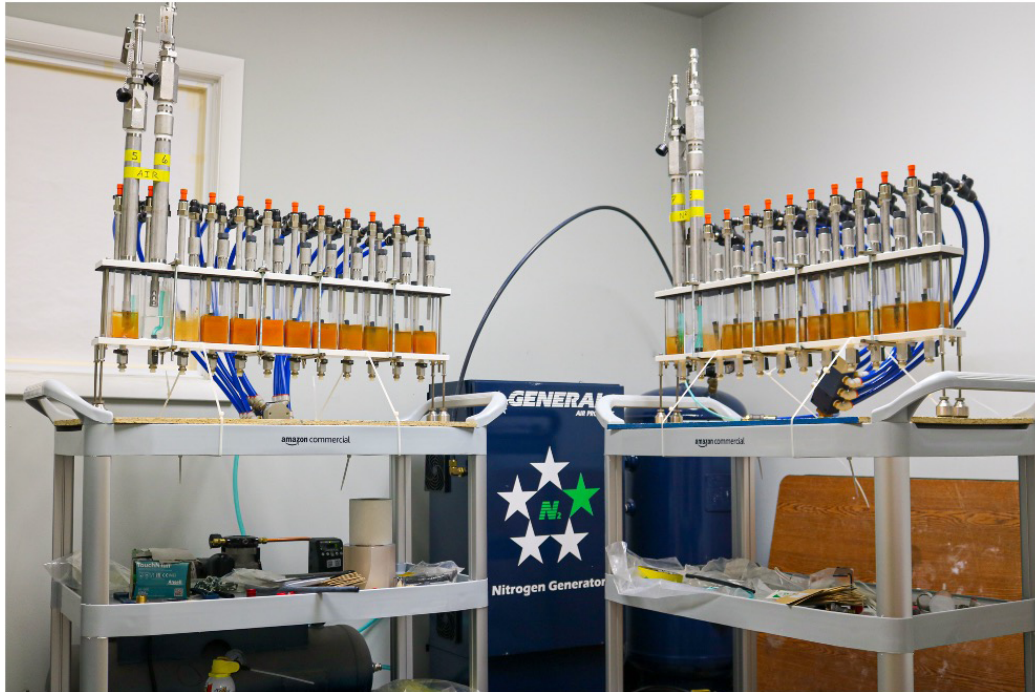
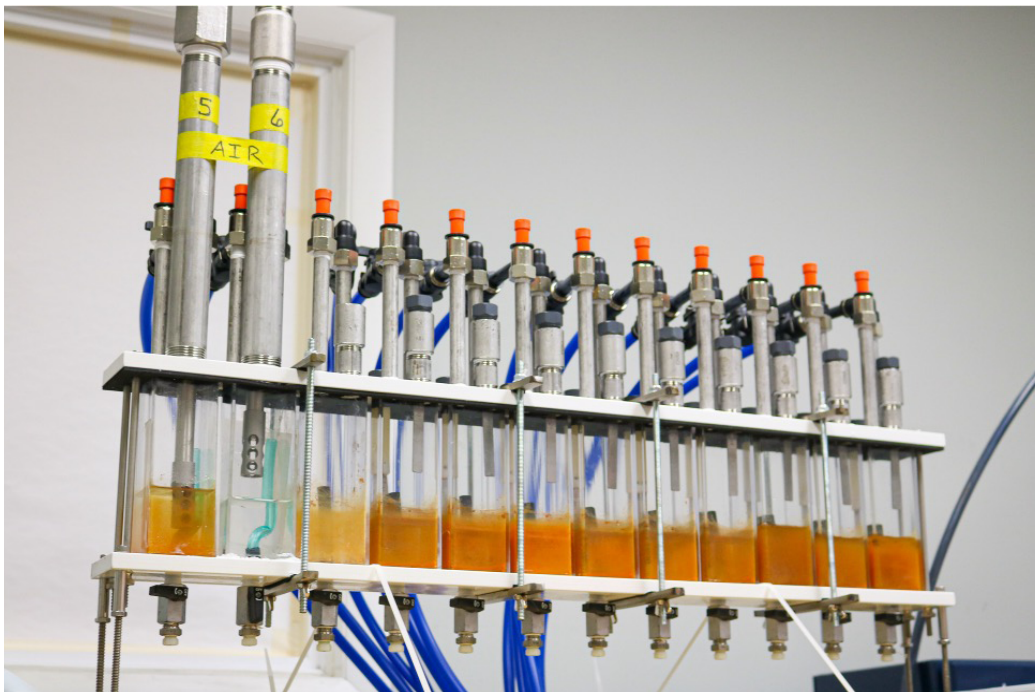
12 chambers partially filled with water where coupons made from C1018 carbon steel are submerged.

Each test station contains 12 chambers partially filled with water to simulate real-world conditions where water accumulates in sprinkler piping. Coupons made from C1018 carbon steel are submerged and exposed to the vapor phase in each chamber. Corrosion is measured using mass loss, visual inspection, and electrical resistance (ER) probes at six-month intervals. The following information provides two sets of findings over the first year of testing.
