White Paper

Better Corrosion Protection for Dry and Pre-Action Fire Sprinkler Systems - Vapor Corrosion Inhibitors Out Perform 98 % Nitrogen in Mil Loss Testing

December, 2024

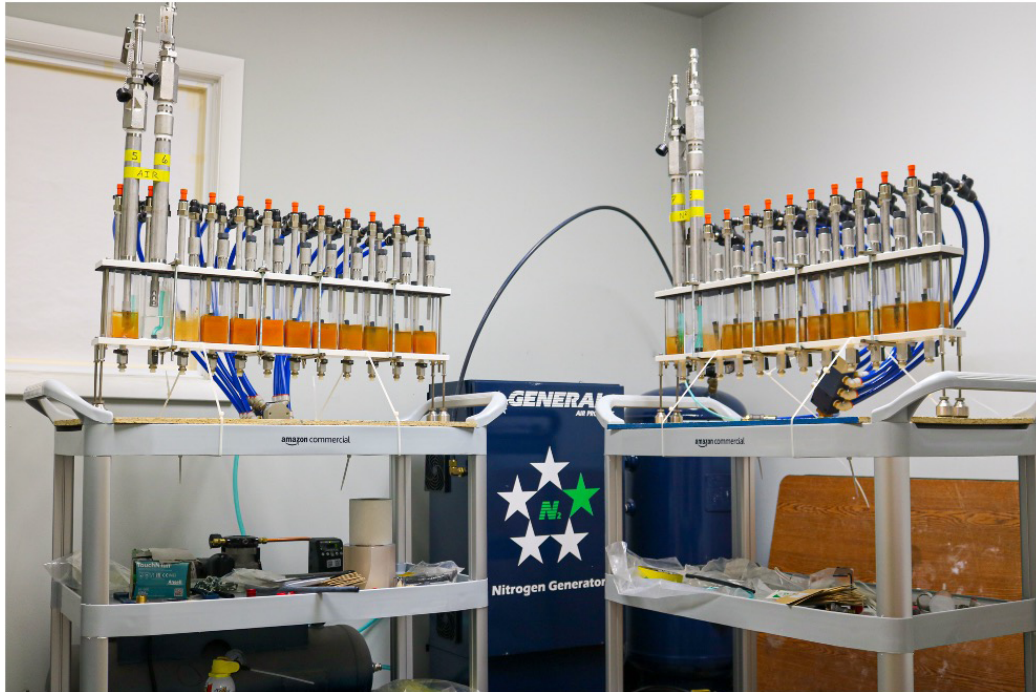
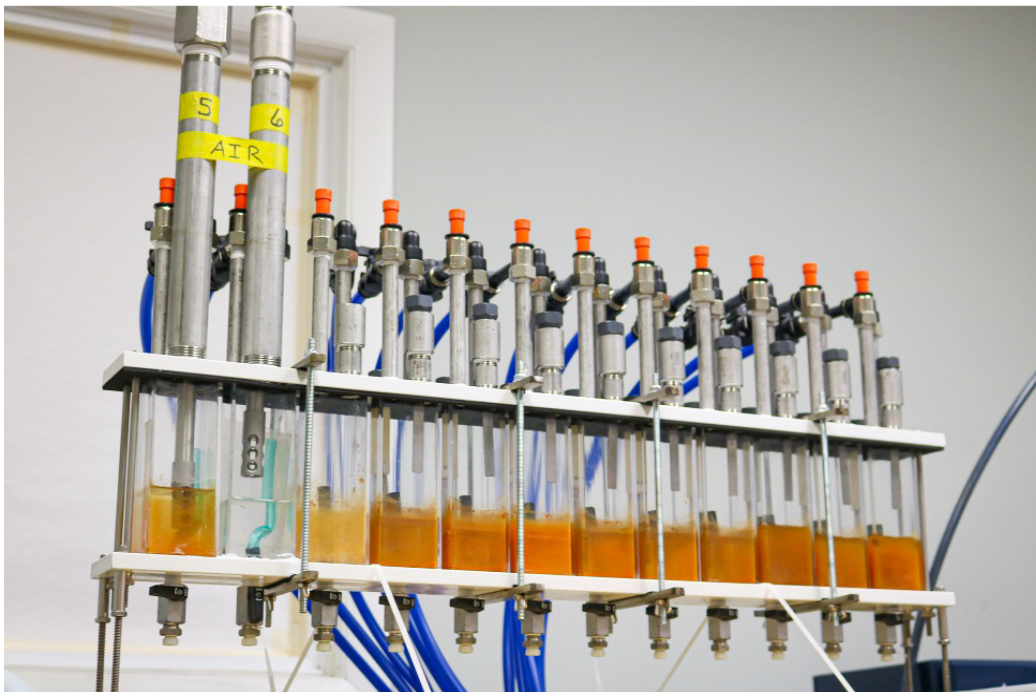
12 chambers partially filled with water where coupons made from C1018 carbon steel are submerged.

Each test station contains 12 chambers partially filled with water to simulate real-world conditions where water accumulates in sprinkler piping. Coupons made from C1018 carbon steel are submerged and exposed to the vapor phase in each chamber. Corrosion is measured using mass loss, visual inspection, and electrical resistance (ER) probes at six-month intervals. The following information provides two sets of findings over the first year of testing.
